Targeted Interventions on Low Volume Rural Roads in Mozambique

AFCAP Project Phase 2

QUARTERLY PROJECT PROGRESS REPORT NO.3

FEBRUARY 2011

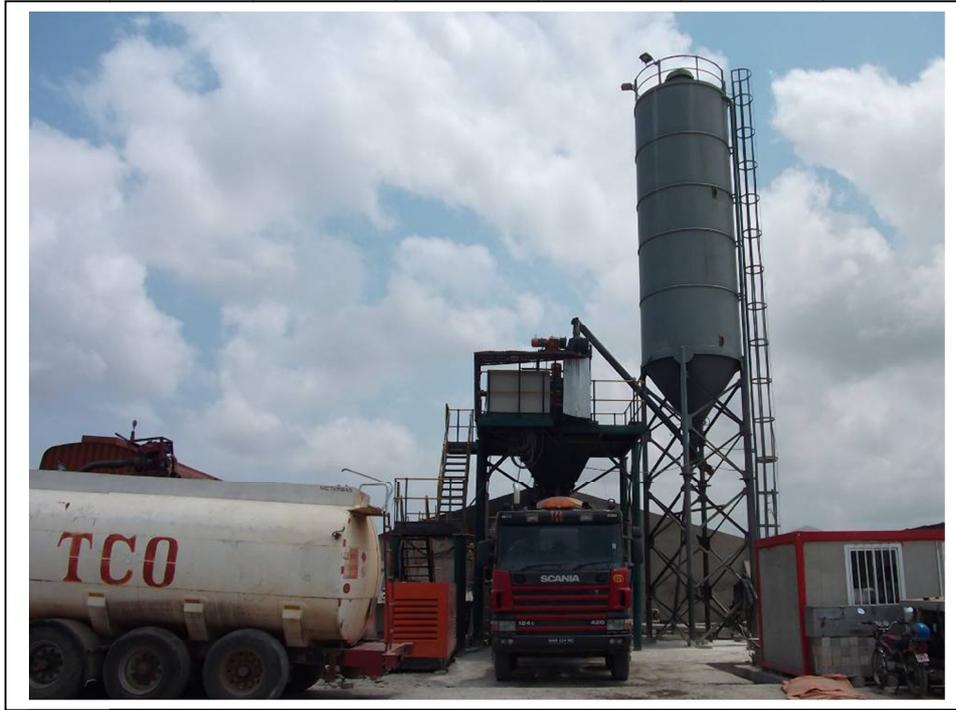
- d. The contractor had promised to use the concrete plant in Beira Town to mix the ETB, ~~Figure 4-1~~ [Figure 4-4](#). This would have been the best option because plant mixing produces better quality of ETB and productivity is usually high at about 8m³ in 20mins. However, it has come to light that the plant is now committed to other works and will not be available for the project.

Figure 4-1 TCO's Concrete Plant for ETB Mixing

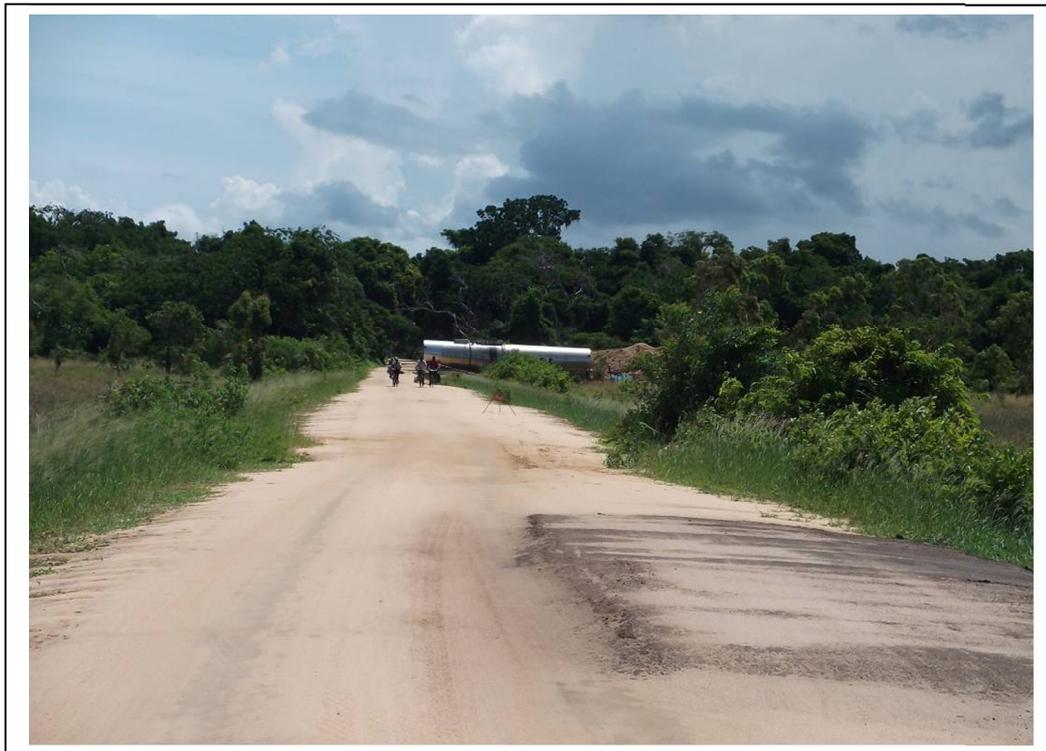
Figure 4-2 Trial section for ETB Construction

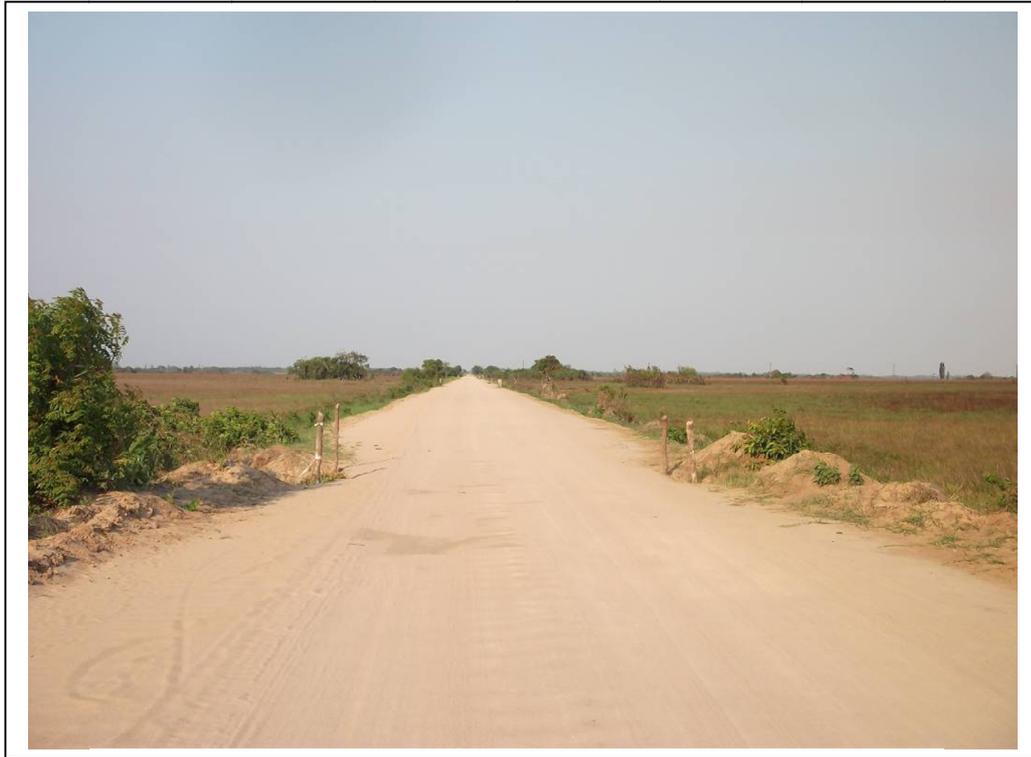
- b. The existing culverts in both sections are about 5m in length and the carriageway was designed to be 6m wide. Since there is no budget for drainage improvements it was suggested that the carriageway be narrowed to 5m with 0.5m sealed shoulders in between the culverts. The general carriageway width for other sections built under RRIP/AFCAP project was 5m with 0.5m shoulders. The difference in design on this project of a 7m wide road was due to the high water levels during flood periods. A wide road reduces the extent of moisture ingress from the sides and this helps to keep wheel tracks at below optimum moisture content. There are 4 culverts, two on each section which are less than 4.5m long and will need to be extended, Figure 4-3.

Figure 4-3 Culverts needing extension

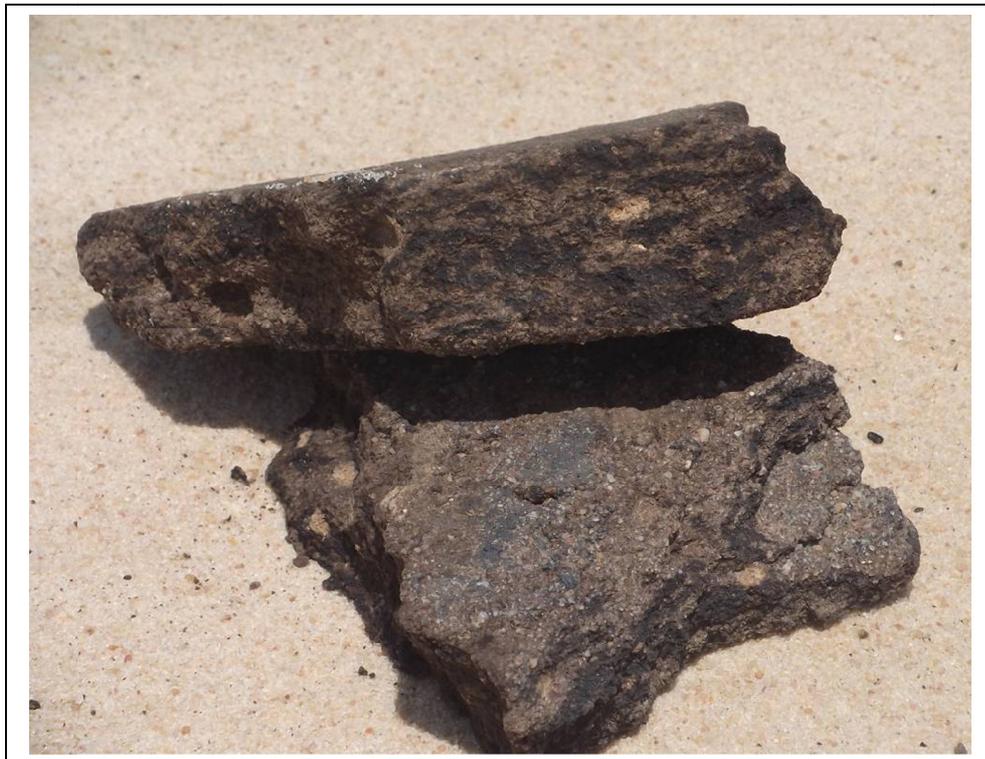
- b. The workmanship was poor and a lot needs to be done to improve it. The mixing was inadequate and there are portions in the ETB layer matrix with little bitumen and others portions which are rich in bitumen.

- d. The strength of the ETB as laid showed good resilience against traffic and weather elements. This is illustrated in the ETB blocks, [Figure 4-4](#), sampled from the cured trial sections. The ETB cannot be used as wearing course but the trial section has been open to traffic and weather elements for more than two months and there has been very little damage. Some of the ETB which fell on the side slopes has been submerged in water for almost two months since the flood waters rose and these have maintained much of their strength. This is a good sign.

Figure 4-4 Block of cured ETB from trial section

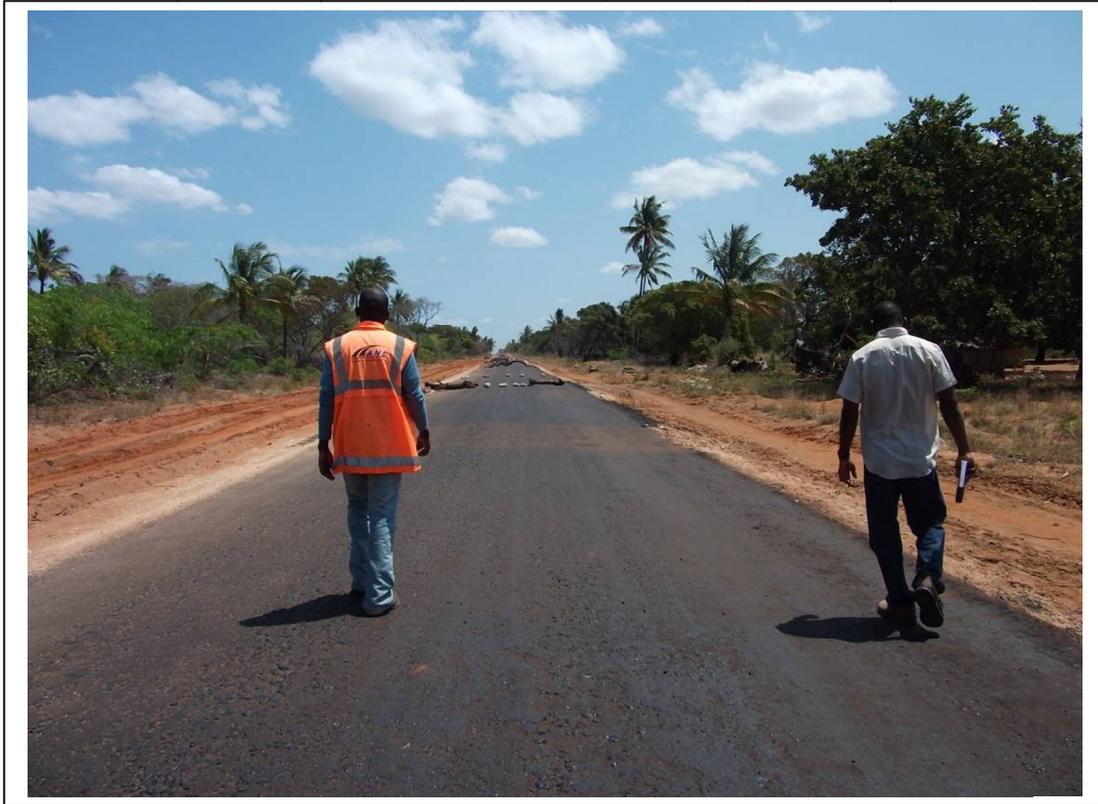
The construction of the base was completed in the previous reporting period. Unfortunately the completed base was trafficked for a long time before priming. As a result, the surface of the base became rough. Nevertheless priming was applied on the rough base. The newly-acquired binder distributor was used and it worked well, producing a prime coat that met the specifications (an application rate of 0.6L/m² of MC30 is specified for the Otta seals on trial sections under AFCAP). The prime cured properly before surfacing was applied, [Figure 4-5](#) ~~Figure 4-5~~.

Figure 4-5 Primed section ready for Otta seal surfacing

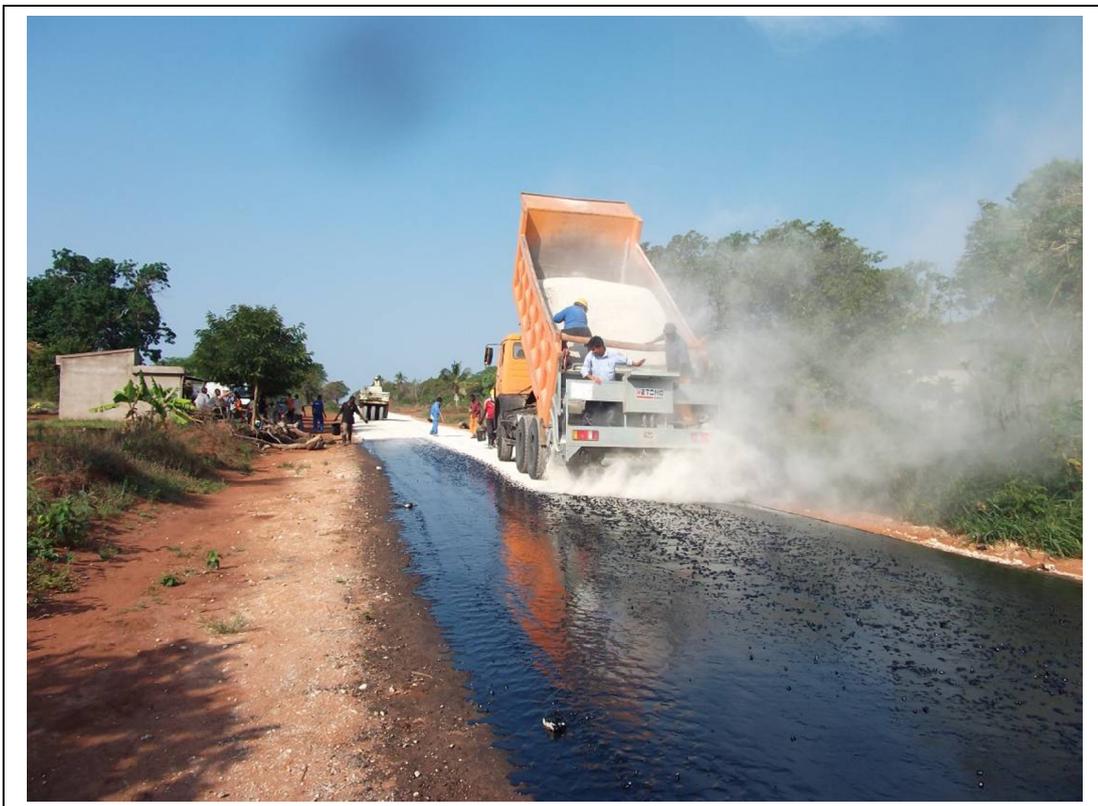
The dust in the aggregate was of major concern, ~~Figure 4-6~~ ~~Figure 4-6~~, but there was not much that could be done without escalating costs through repeated sieving. However, the nature of the dust is such that it could act as a filler because of its gritty nature. It was decided to use the aggregate as it was.

Figure 4-6 Dusty calcrete aggregate

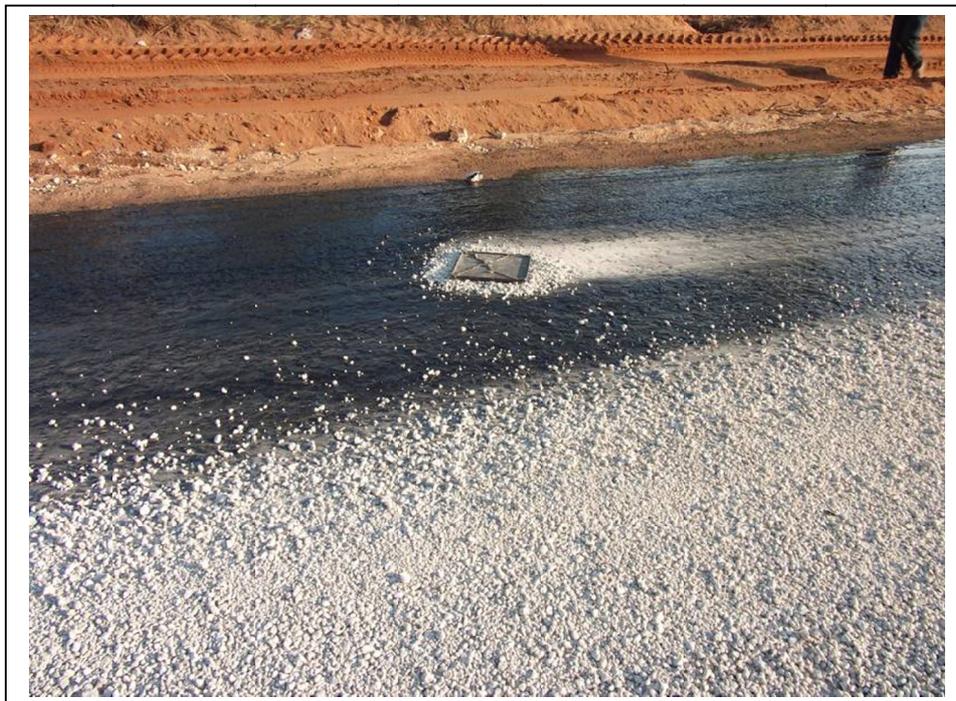
The application rates of stone were measured using the tray and balance, [Figure 4-7](#). This measurement was carried out regularly in order to control the application rates of the aggregate.

Figure 4-7 Tray test for control aggregate application rate

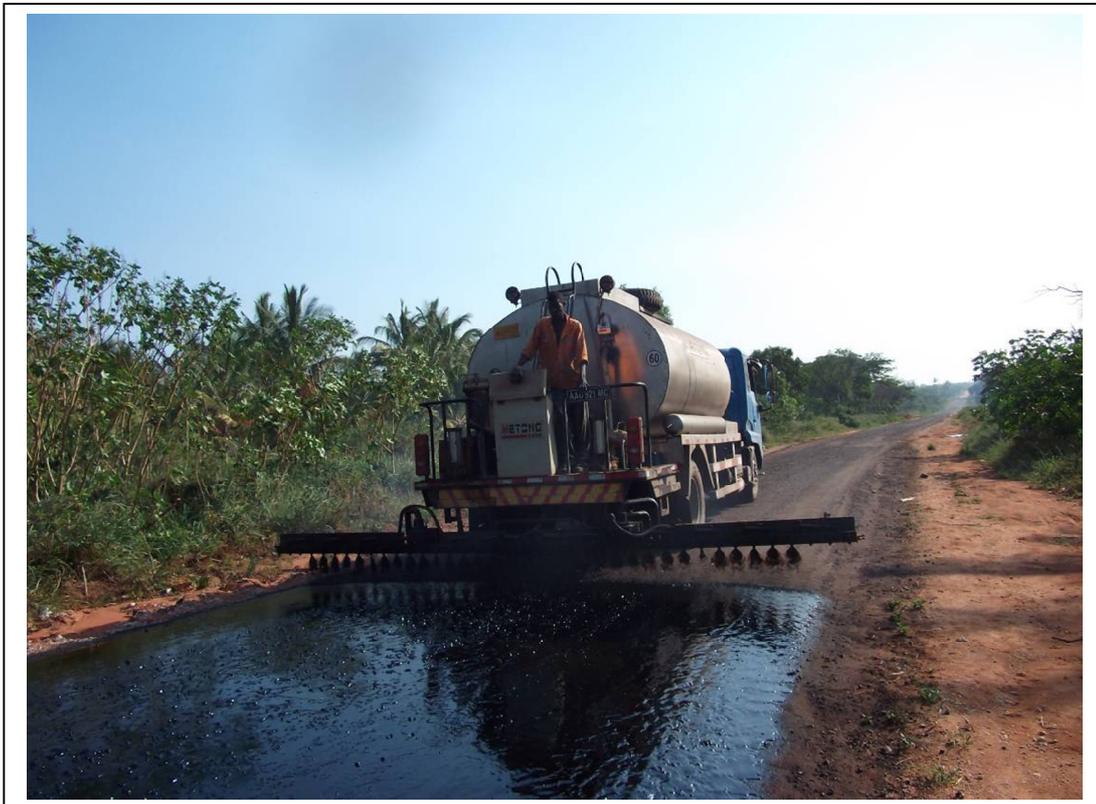
2. *Equipment.* There was a major problem with the BD. The spray bar clogged frequently and it took a long time to unblock. This is actually an inherent problem with the equipment. The spray bar had no insulation and therefore the bitumen cools down rapidly and becomes too viscous to flow properly (~~Figure 4-8~~~~Figure 4-8~~). Clogged nozzles adversely affected the even distribution of bitumen. This normally shows up as stripping in areas starved of bitumen. The contractor did not have adequate tools on site. The burner which was supposed to be used to heat and unblock the spray bar was too small and not useful at all. The BD did not have a hand lance which is used for corrective spraying. There weren't enough hard brooms. The chip spreader was also, at times, clogging up and sometimes not spreading aggregate uniformly.

Figure 4-8 Binder application and illustration of blocked nozzle
